Western Fire Center, Inc.

**Testing in Accordance with SFM
Standard 12-7A-1:
*Fire Resistive Standard for
Exterior Wall Siding and Sheathing***

LP[®] FlameBlock[™] Fire-Rated OSB Sheathing (7/16" Minimum
Nominal Thickness) with Various Claddings:

**PN# 10023
Report No. 10023.1**

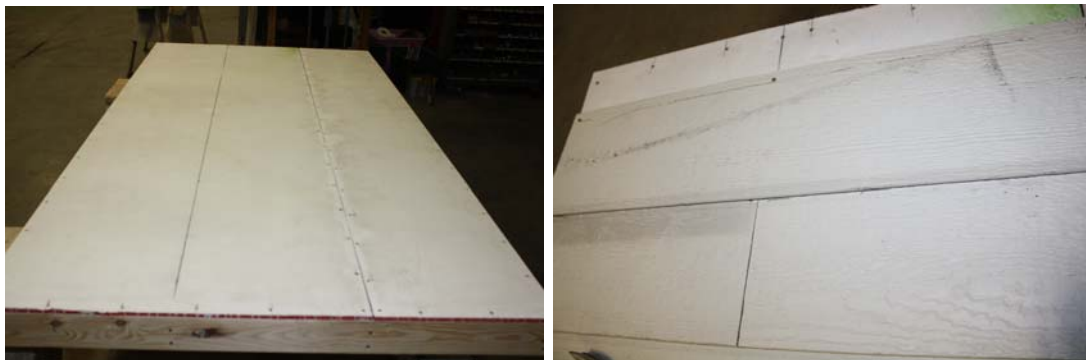
Test Series No. 1: Construction Photographs – Lap Siding (note butt joints every other course)

- **Sheathing: LP FlameBlock™ 4'x8' Fire-Rated OSB sheathing, 7/16" minimum nominal thickness (reference ICC ESR-1365)**
 - Minimum Pyrotite thickness of 0.06" applied to fiberglass mat
 - Pyrotite laminate applied to one face of OSB sheathing [exposed (fire) side]
- **Cladding: SmartSide™ Precision Series Lap siding (limited to strand substrate)**

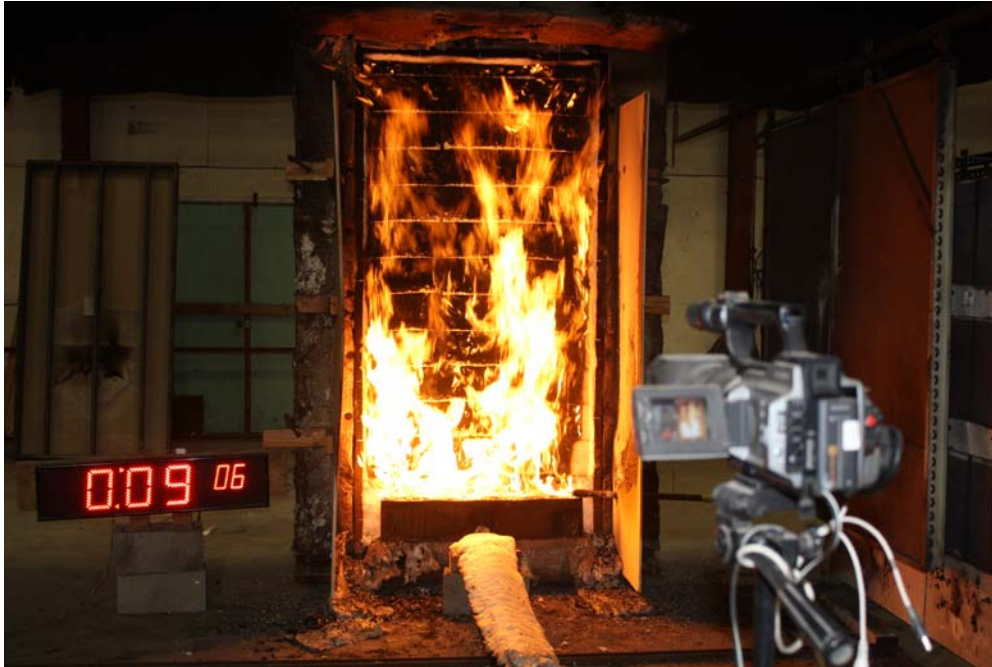
Prior to burner termination

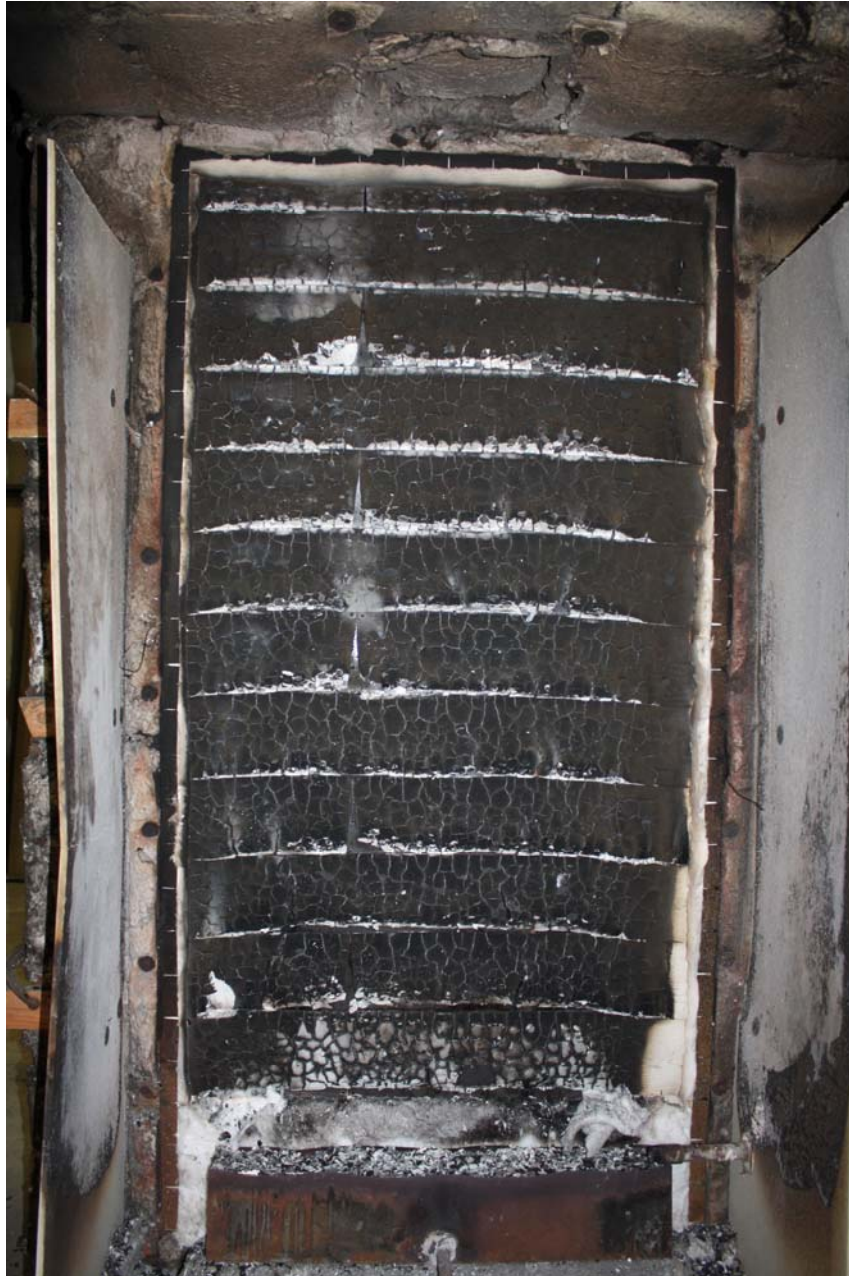
Exposed face at test termination

Trial	Result	Notes
A (Test 5)	Pass- no signs of flame-through or glow on unexposed side	Cladding ignited at 50 s with vigorous flaming, flames out at 16 min, glowing combustion at various locations on sample surface until test terminated at 70 minutes - IR imaging shows diminishing temps on unexposed side at test termination
B (Test 7)	Pass- no signs of flame-through or glow on unexposed side	Cladding ignited at 45 s with vigorous flaming, all flame out prior to 20 min, glowing combustion at various locations on sample surface until test terminated at 70 minutes - IR imaging shows diminishing temps on unexposed side at test termination
C (Test 8)	Pass- no signs of flame-through or glow on unexposed side	Cladding ignited at 49 s with vigorous flaming, glowing combustion at various locations on sample surface until test terminated at 70 minutes - IR imaging shows diminishing temps on unexposed side at test termination
